Aerial Drone Inspection: <REDACTED>, Hornsby 2077

Prepared by Chief Remote Pilot - Sean Pettinger ARN: 126805
REOC: 9207

Summary

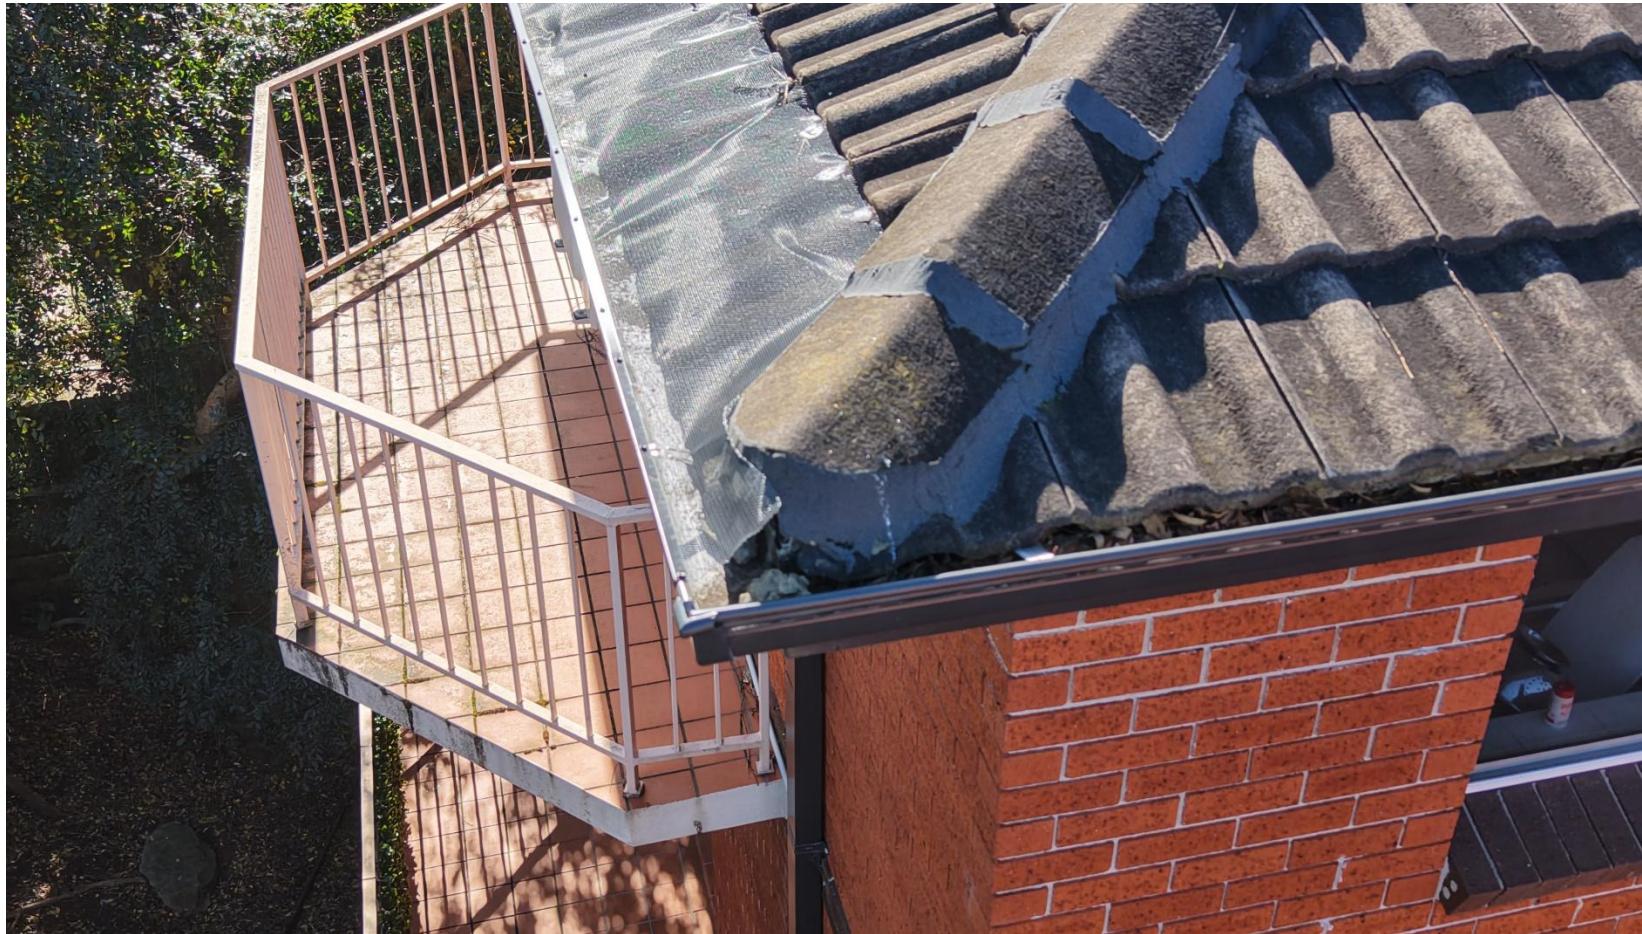
- SW corner of the building

Figure 2 Comments: Appears fine, extremely small amounts of debris but otherwise v.well maintained

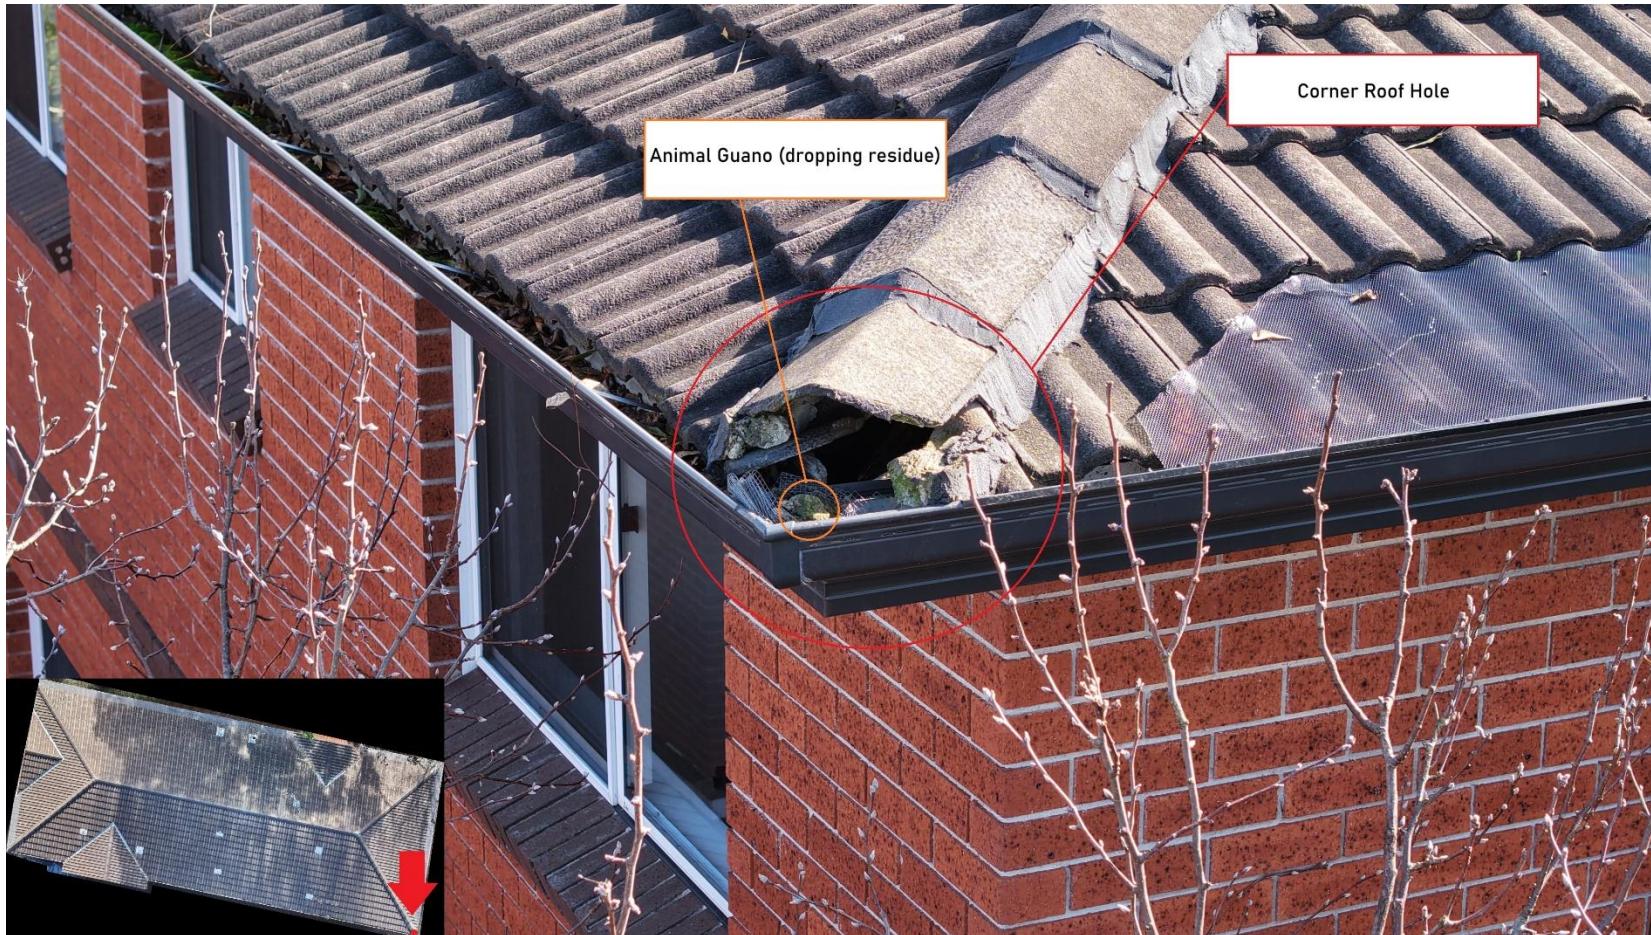
- SE corner of the building

- **Hole in South-East and North-West Roof Edge**
 - High possibility of exacerbating water retention of roof if left untreated and possibility of animal infestation (has already occurred)

Figure 3 Comments: Clear hole and entry point for wildlife, Tile debris discolouration associated with animal residue

- Recommendation – Refer to a professional roof repair company but likely needs to be Remedied within the next 3 months
- **Minor surface debris Blocking gutters**

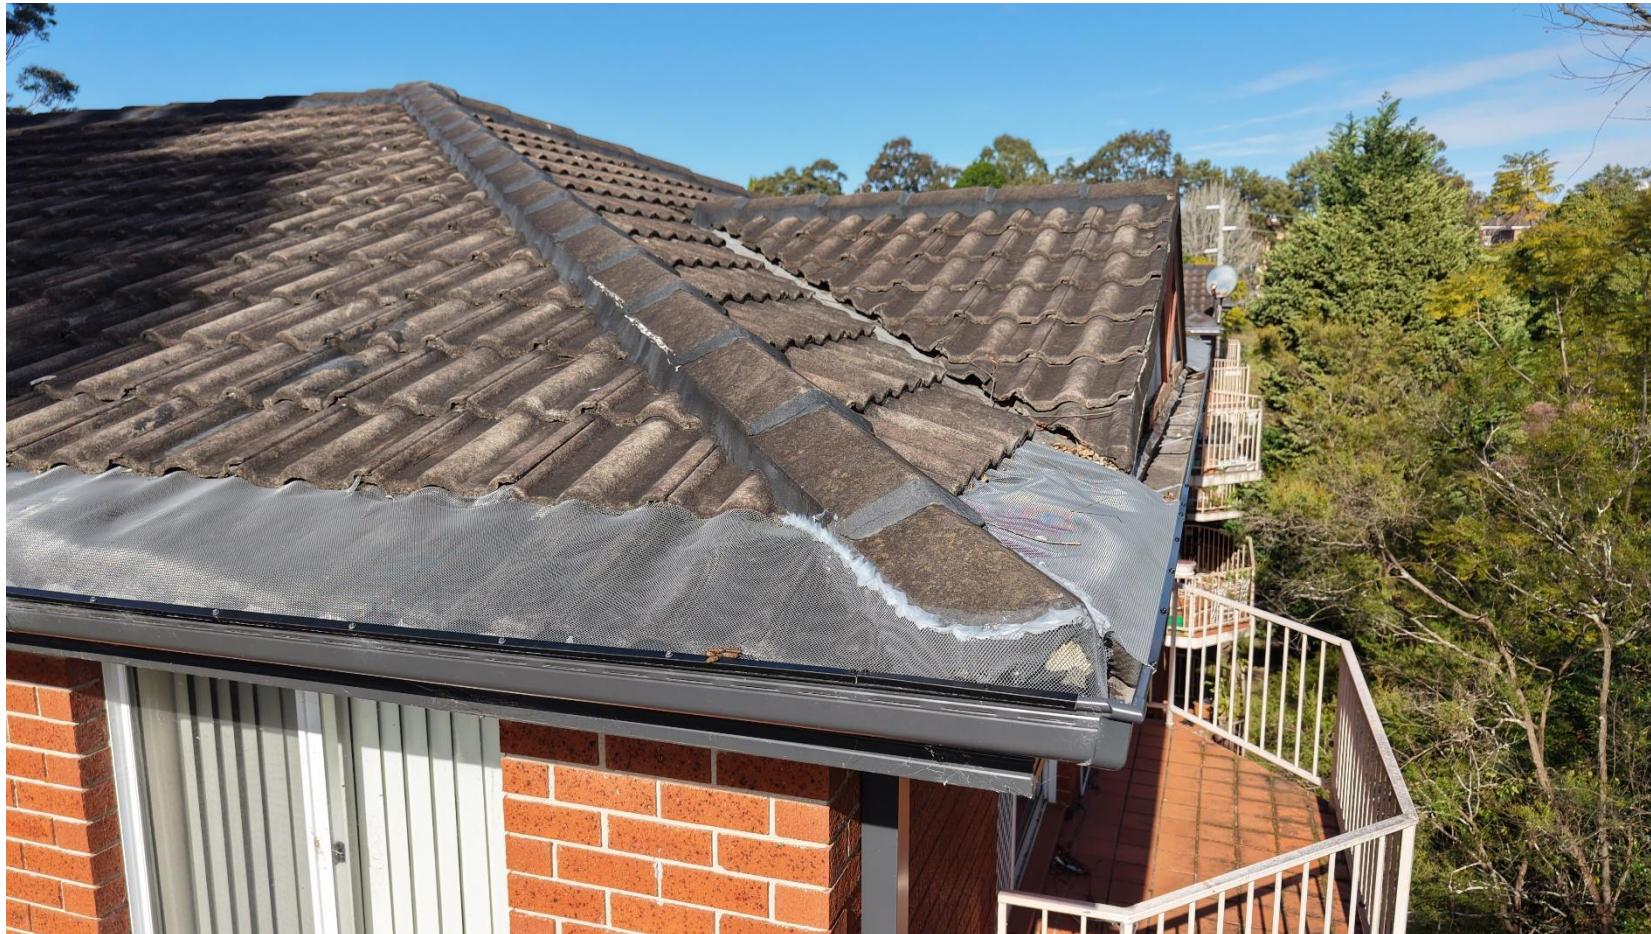
- NW corner of the building

Figure 4 Comments: V.Small hole and entry but appears to have been covered previously. May Need a bit of retouching though.

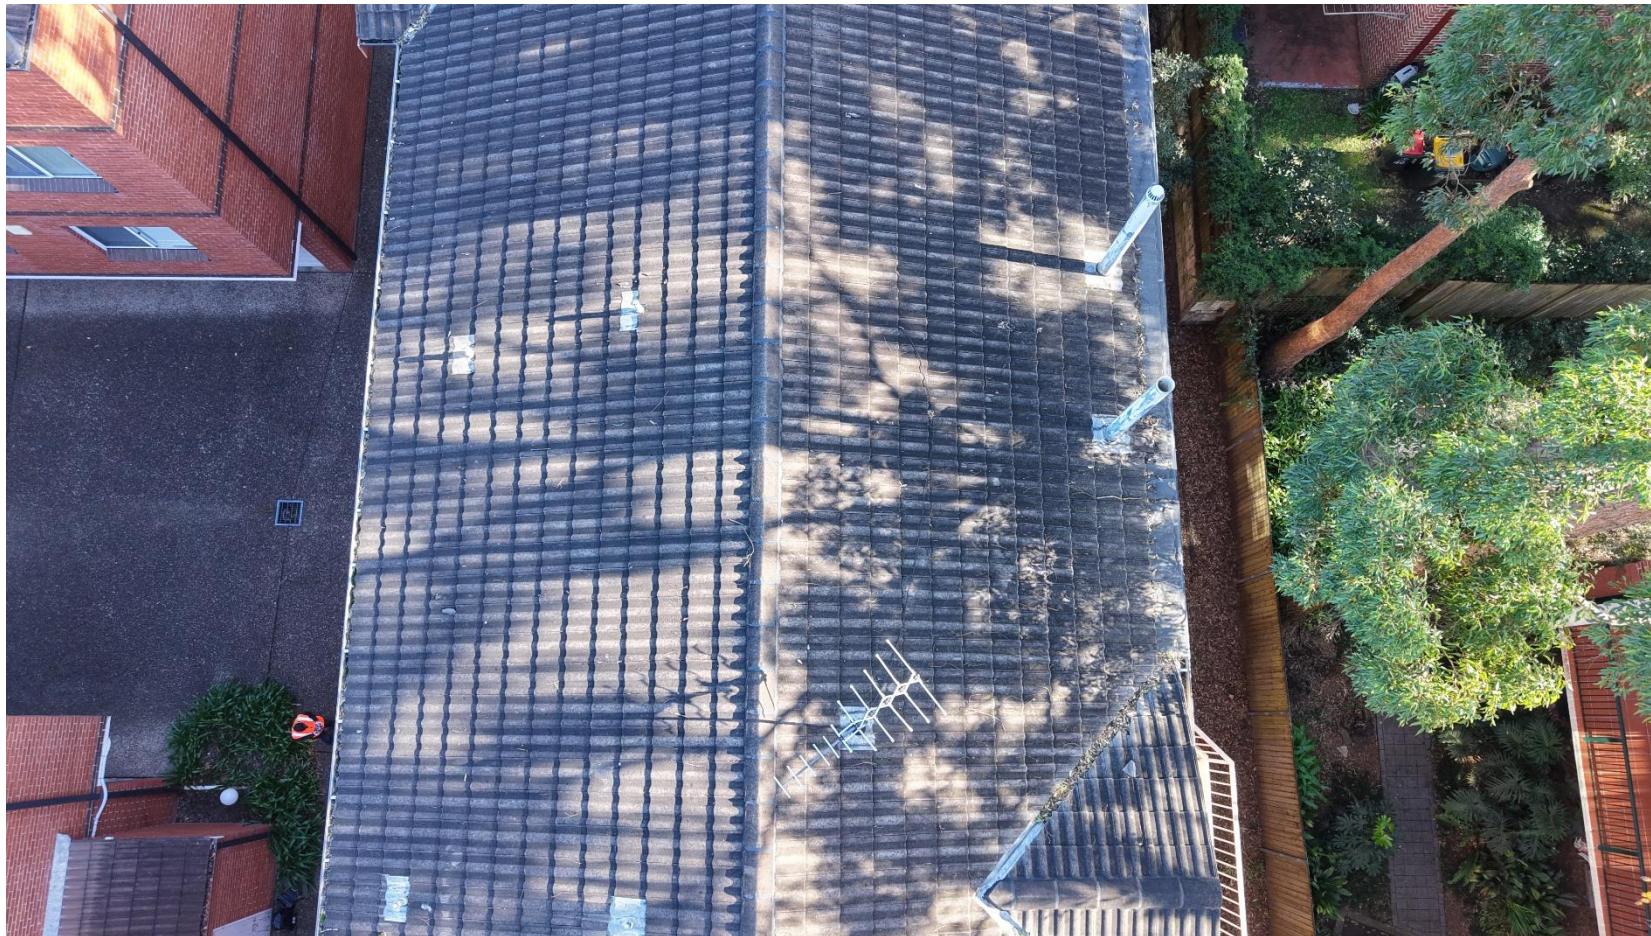
Ridge

Figure 5 Comments: No Significant Concern, Appears fine

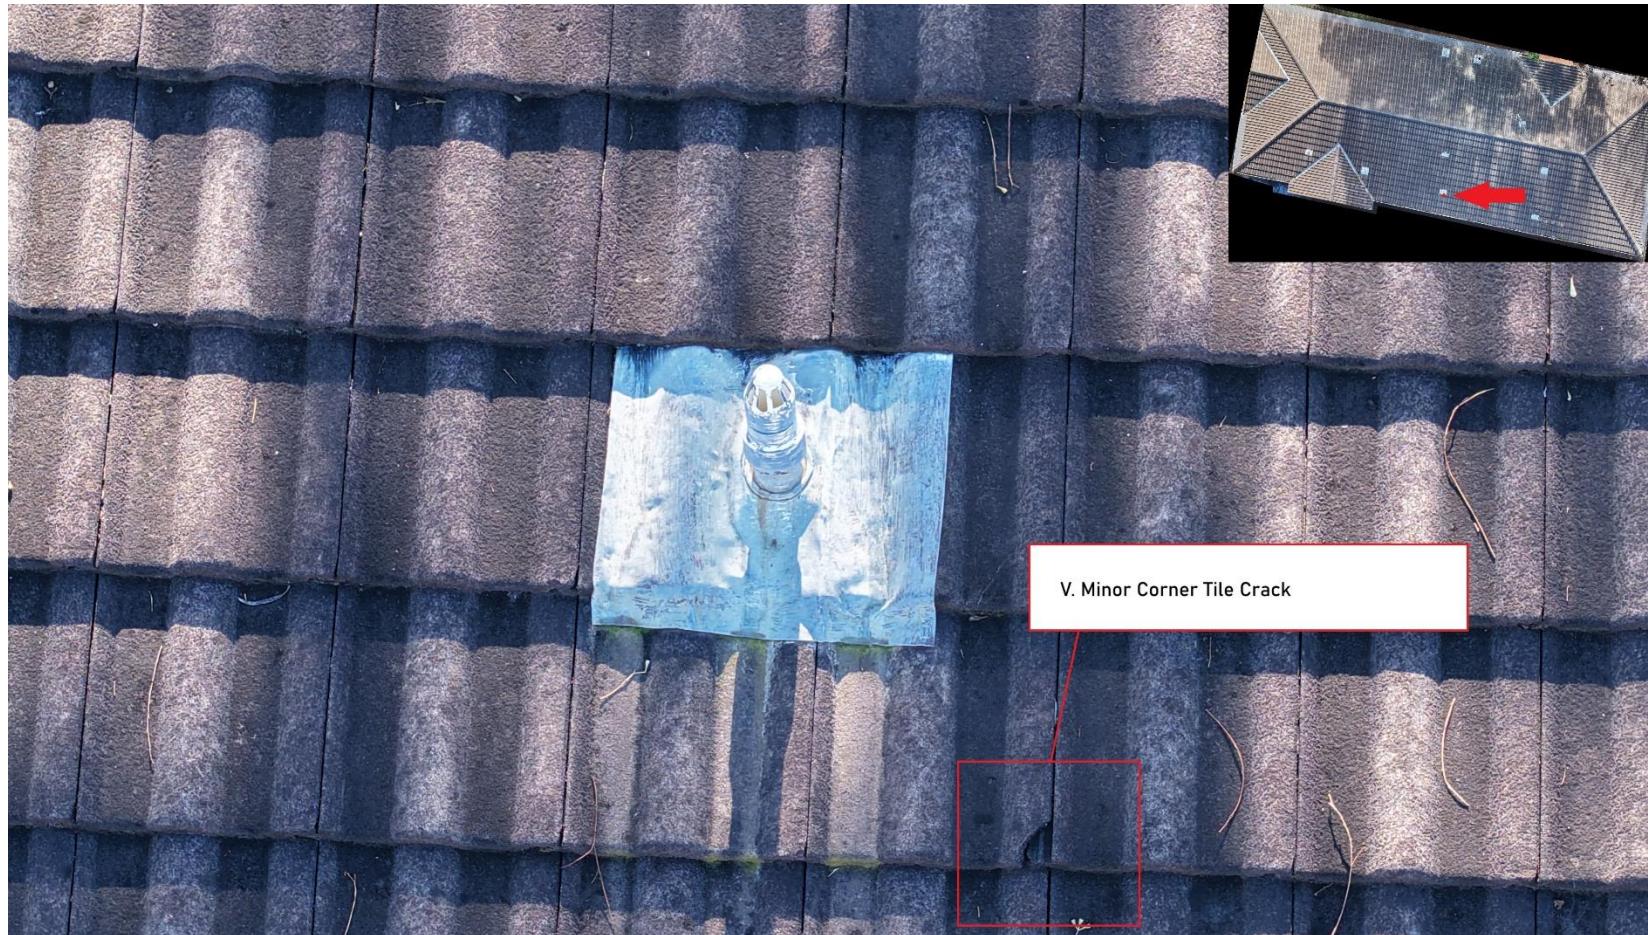
- Recommendation – N/A
- **Damaged tiles (light damage)**
 - Possibility of exacerbating water retention of roof if left untreated and may lead to further damage.

Figure 5 Comments: All Extrusions appeared fine, only this one had a minor crack in the tile

- Recommendation – Refer to professional roof repair company
- **Missing Exhaust Cover**
 - Missing Exhaust Cover, Possible animal entry point.
 - Recommendation – Replace

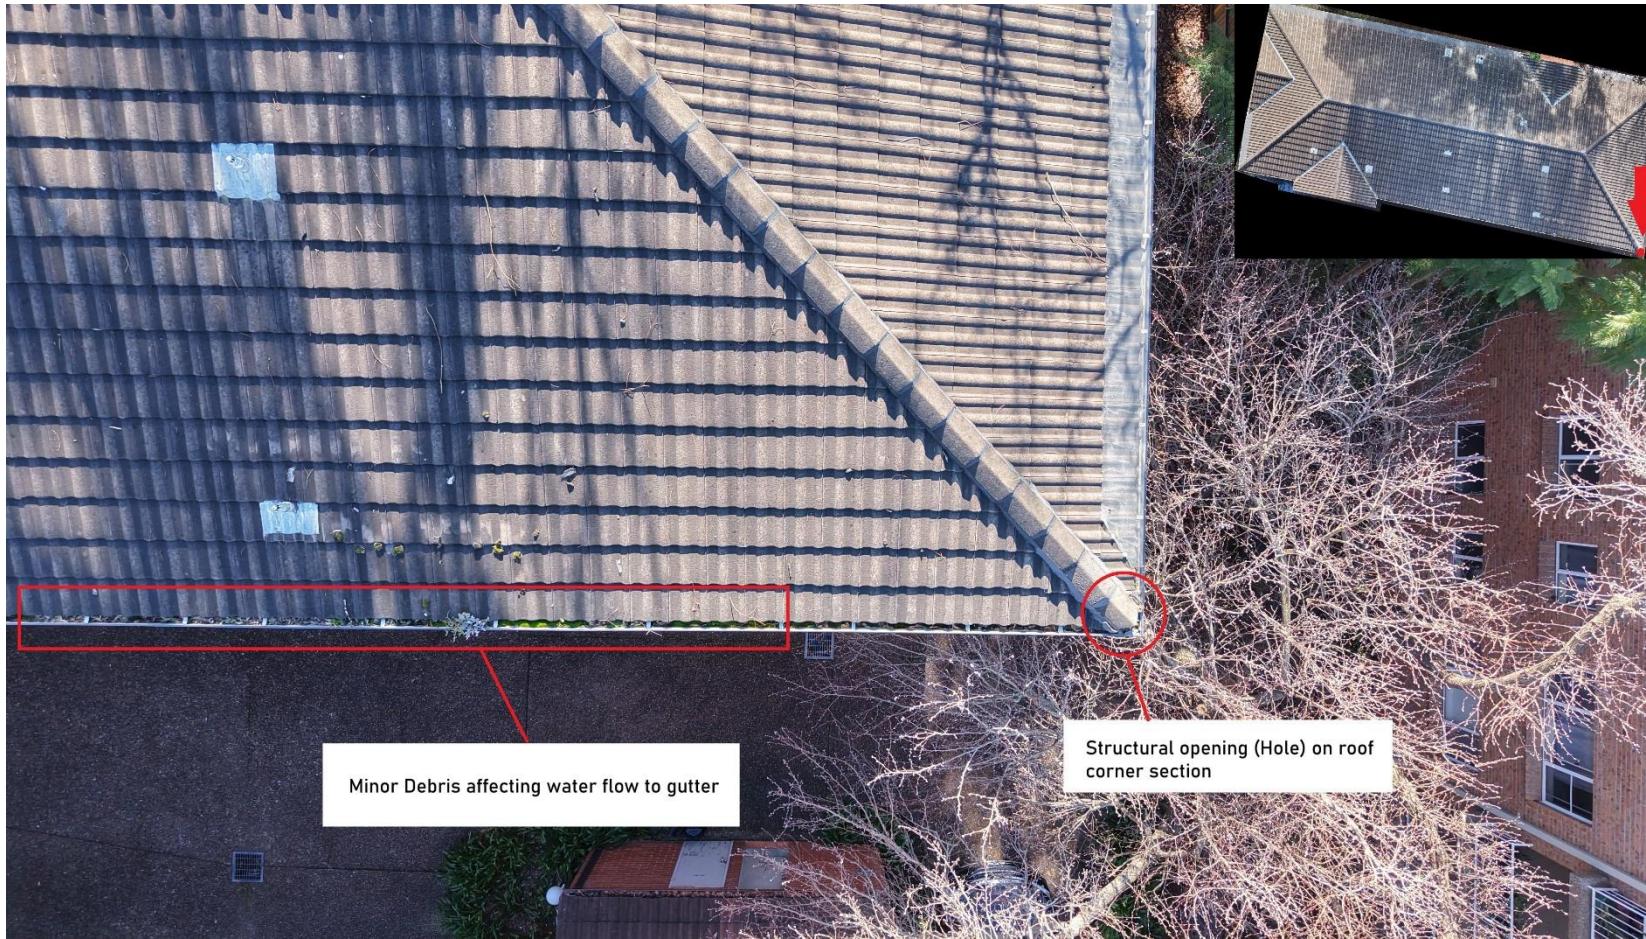
Surface + Debris

- Surface debris including (broken tile fragments, leaves, twigs and rock/cement fragments) are affecting drainage channels and potentially restricting proper drainage during rainfall.

Figure 6 Comments: Some problematic debris is present on S side of building

- Clearance of debris is recommended within the next 6-12 months
- **Deteriorating/missing Wooden panels (West)**
 - Exterior Panels along western Dormer top-plate and rafters are showing signs of deterioration (has already occurred)

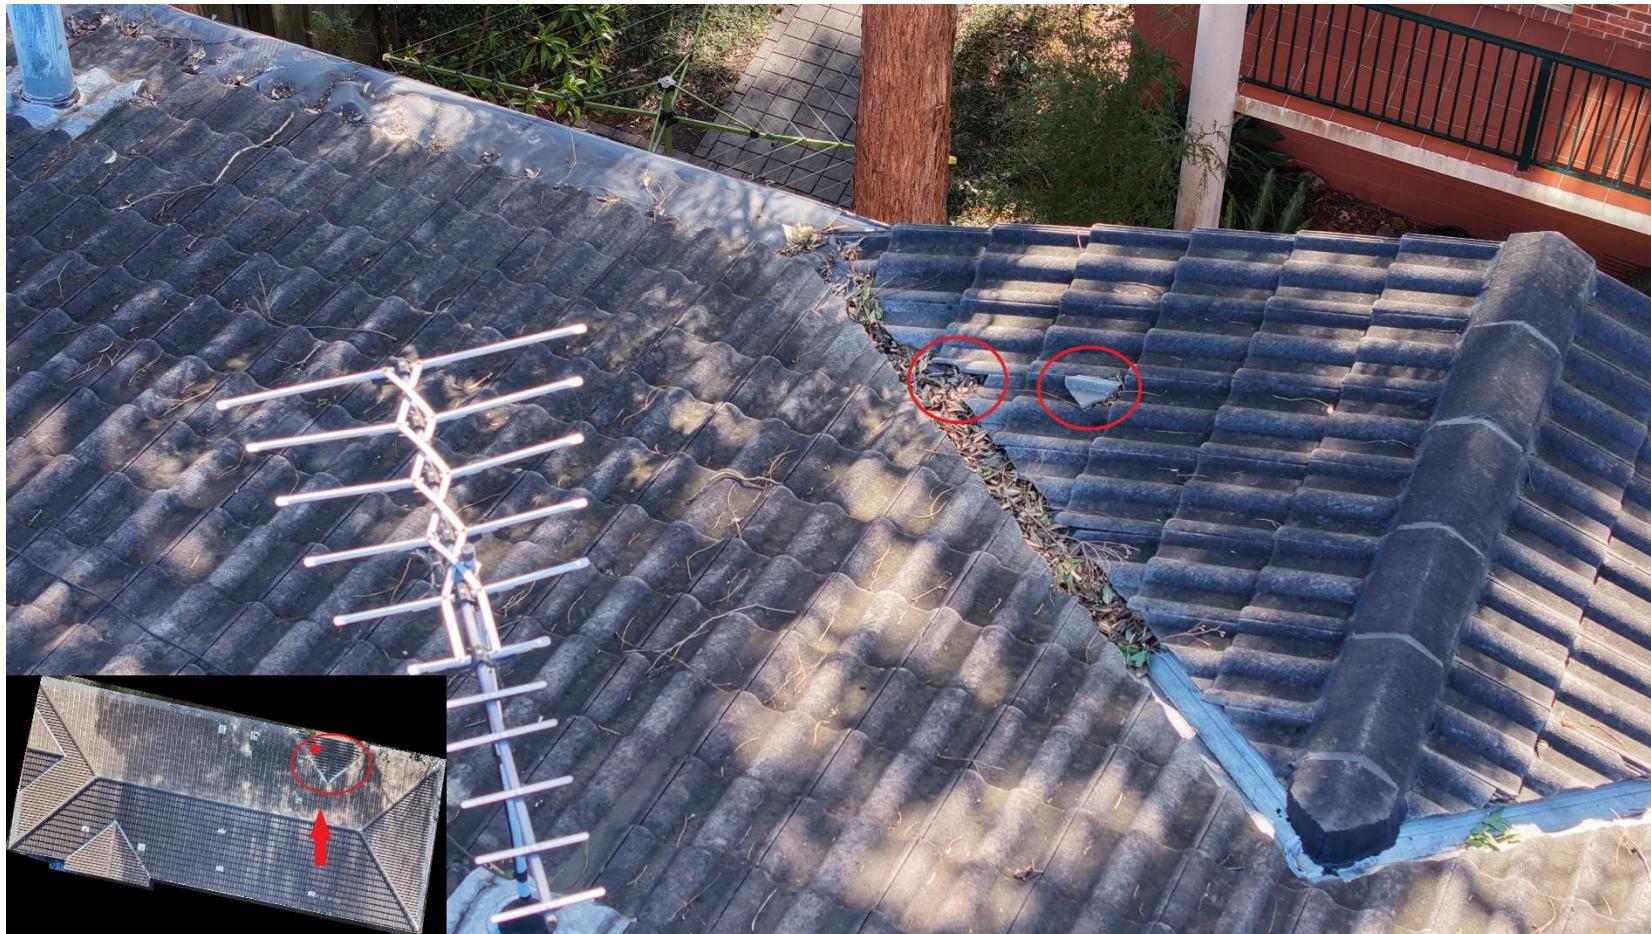
Surface + Debris (2)

Figure 7 Comments Broken Tile and debris

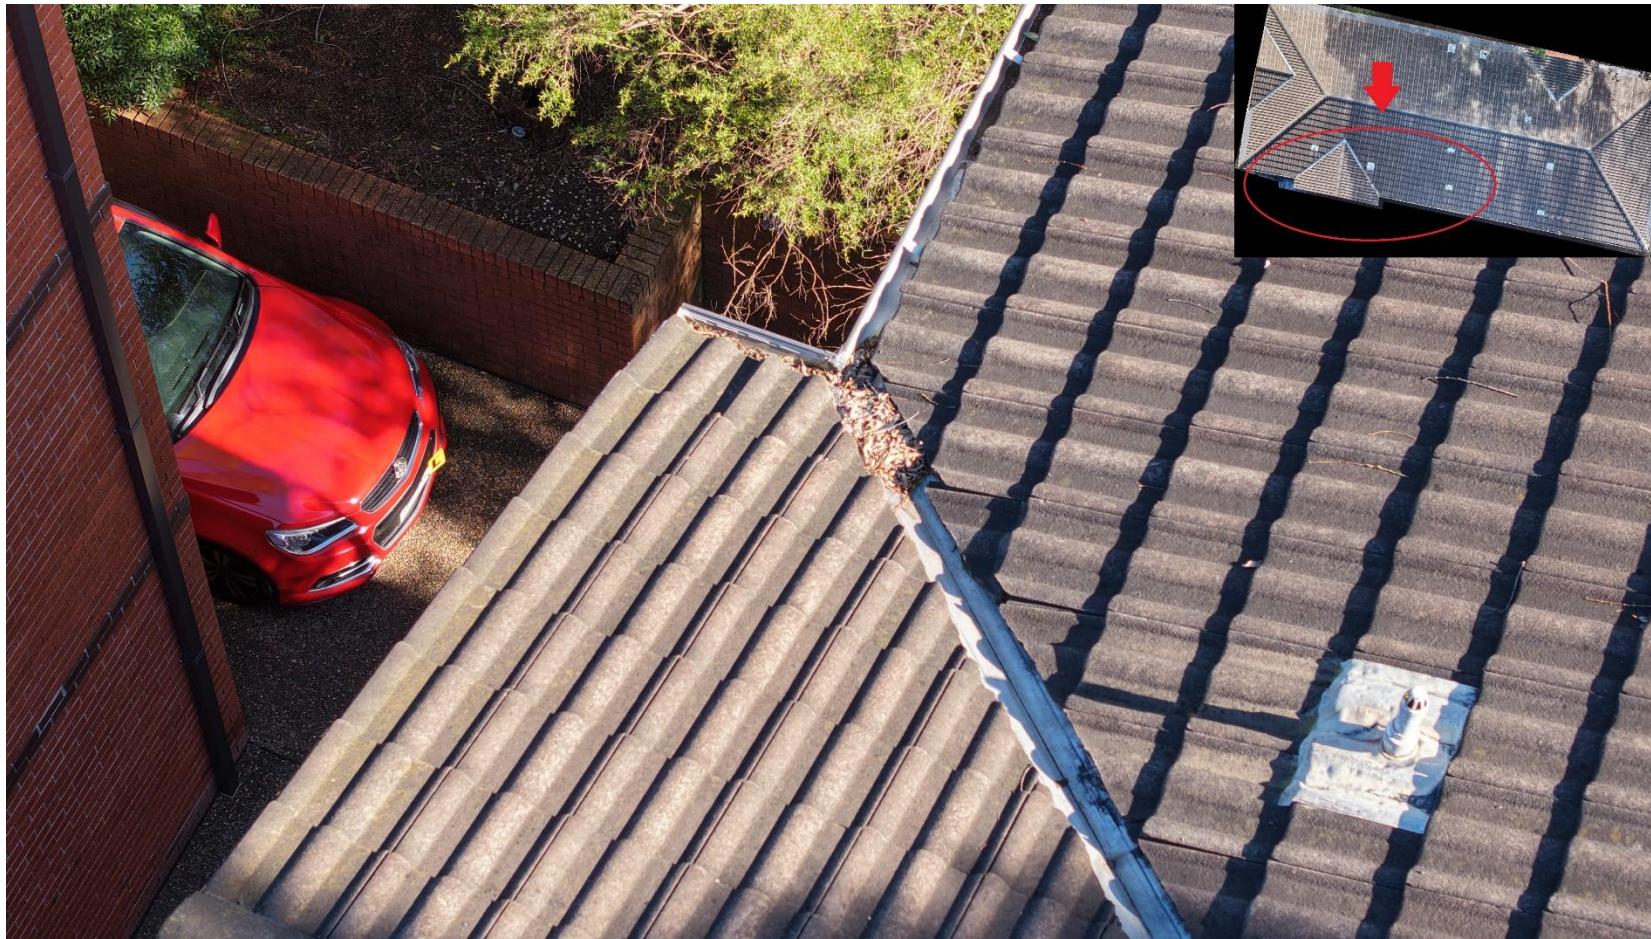
Surface + Debris (3)

Figure 7 V. small amount of debris, but is present throughout the S and W side of the building

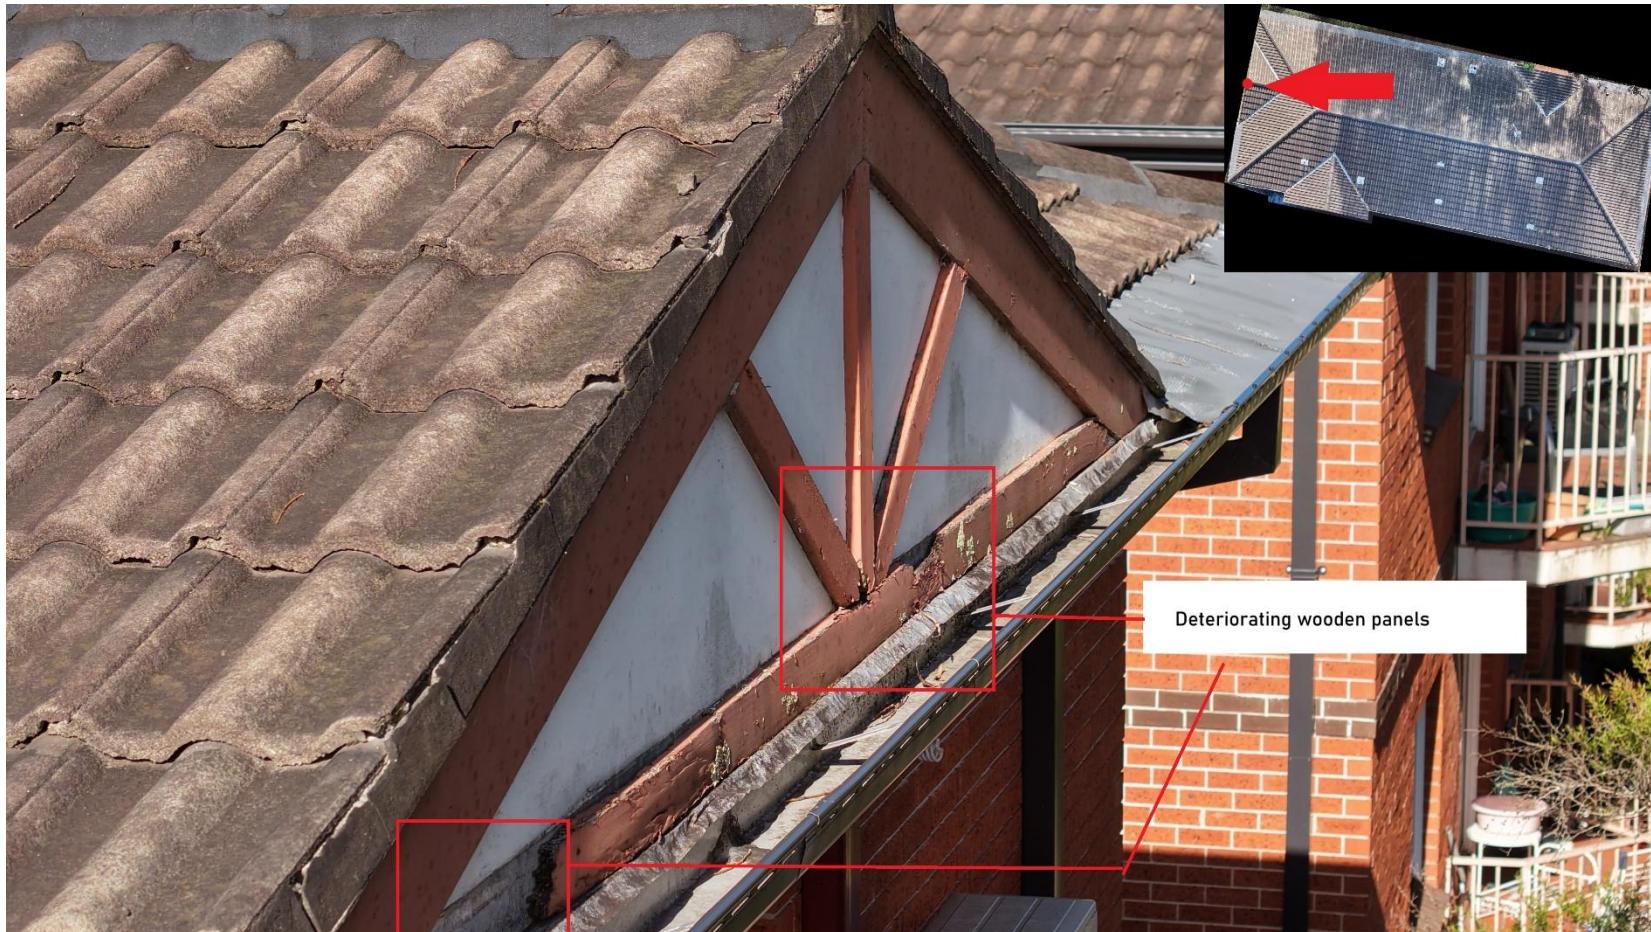
Structural damage/ Deterioration

Figure 8 Comments Slight damage affecting the exterior frame

- Recommendation – Refer to a professional roof repair company but unlikely to present any immediate issue.
- **Guano Evidence (North-West)**
 - Fresh animal dropping were observed on the North -West side of the building, the droppings are clearly mammalian.

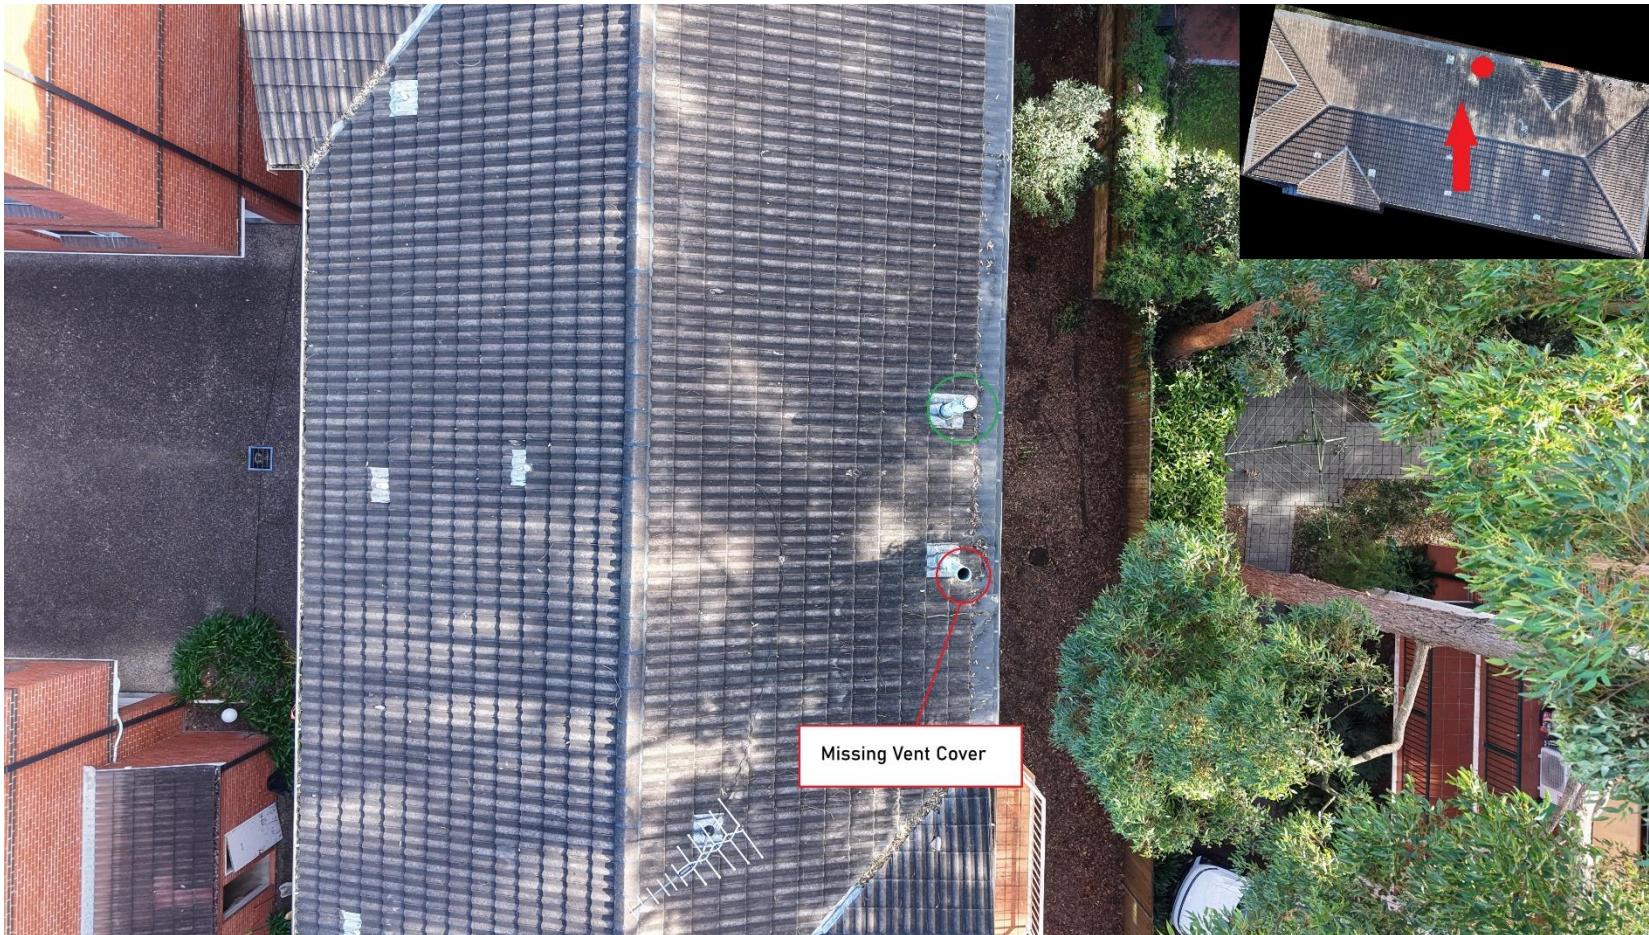
POI Missing Exhaust Cover

Figure 9 Comments Missing Exhaust Cover
