Aerial Drone Inspection: <REDACTED>, Hornsby 2077

Prepared by Chief Remote Pilot - Sean Pettinger ARN: 126805
REOC: 9207

Summary

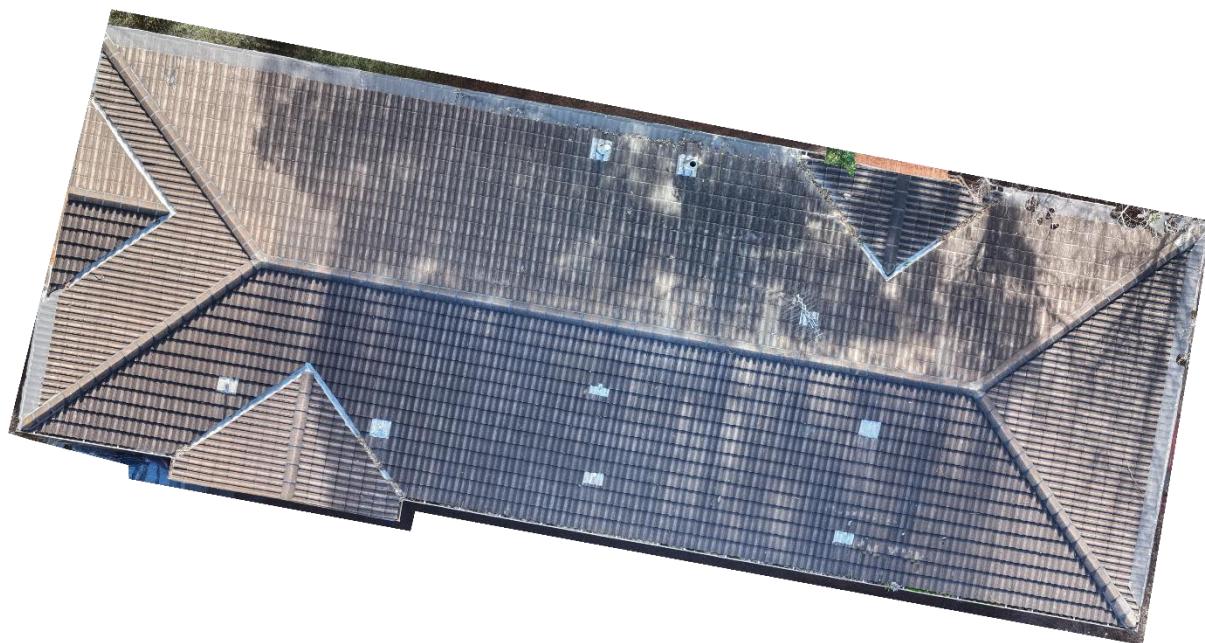
Figure 1 Ortho mosaic made through PIX4D

This report outlines operations conducted on the 28/6/25. Minor defects and points of interest were identified, including roof corner damage, deteriorated timber, and evidence of animal activity. A basic orthophoto has been provided for reference (shown below). Detailed imagery can be found attached in the associated PIX4D folders. (The far North-Eastern corner was unable to be accessed safely and excluded from this report)
